DELHI PARKS AND GARDENS SOCIETY

Site Inspection of Water Bodies of Dwarka conducted by the Committee constituted under judgment of Hon'ble National Green Tribunal in connection with OA No. 299 of 2016 titled as "Diwan Singh & ANR Vs. Union of India & Ors. on 29.11.2016, 30.11.2016 and 2.12.2016. On the basis of Site Inspection detailed report is as follows:-

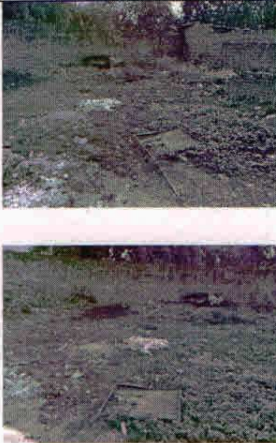
<p>13.</p> <p>G. No. 638</p>	<p>Dhool Siras:- Date of Inspection – 29.11.16</p> <p>Kh. No. 245 (0-14) - DDA</p> <p>The water body belongs to DDA. However, it is found partly encroached. It is also found that dumping of garbage and other construction waste materials is being found at the site. The same needs immediate protection.</p> <p>Direction:-</p> <ul style="list-style-type: none"> • TSM survey • Boundary wall • Tree planting around its sides • Removal of wastes dumps • Deepening at the middle

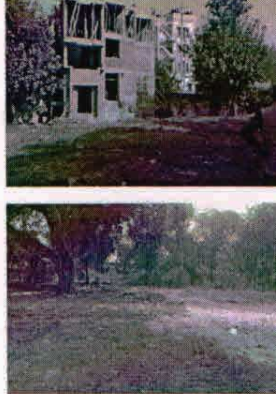
<p>15.</p>	<p>Bagdola:- Date of Inspection – 29.11.16</p> <p>Kh. No. and area to be provided by DDA</p> <p>According to DDA there is no water body exist here. It is a green area instead of water body. It is also known as "Mansa Devi" area. Directions have been given to DDA make it as green belt. There is solid waste dumping here. DDA was directed to provide its Khasra Number and area.</p> <p>Direction:-</p> <ul style="list-style-type: none"> • Remove solid waste from the site • It is located along drain so water can be diverted to water body • Green area with trees be maintained here • TSM survey is also be done.

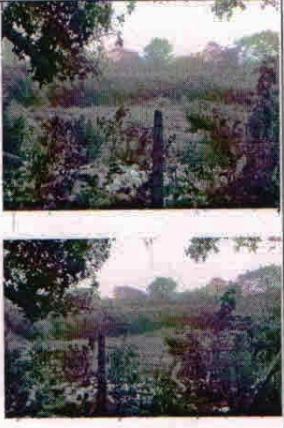
16.	<p>Bagdola:- Date of Inspection - 29.11.16</p> <p>Kh. No. and area to be provided by DDA</p> <p>This water body is situated at C-Block, Sector-8, Bagdola Village. It is seasonally wet. It is along drain hence rain water can be diverted toward it</p> <p>Direction:-</p> <ul style="list-style-type: none"> • DDA to provide the area alongwith Khasra Number of the water body as per records. • It needs gate • Dumped waste and the Bushes need to be removed • Boundary wall needs repair • Plantation be done on its side

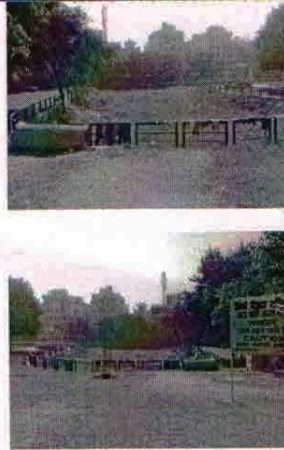
17.	<p>Bagdola:- Date of Inspection - 29.11.16</p> <p>G. No. 927 Kh. No. 32 - DDA</p> <p>This water body belongs to DDA. It is dry.</p> <p>Direction:-</p> <ul style="list-style-type: none"> • DDA to provide the area alongwith Khasra Number of the water body as per records. • Need deepening and draining adjoining rainwater towards recharging pit

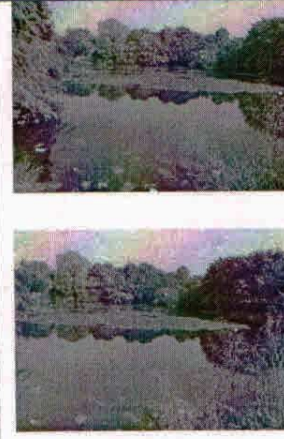
18.	<p>Bagdola:- Date of Inspection - 29.11.16</p> <p>G. No. 925 Kh. No. 1/157 (12-4) - DDA</p> <p>The water body requires cleaning. It was also found that at some place, boundary wall is broken which requires immediate repair. Water is coming from Airport side into the water body through drain.</p> <p>Direction:-</p> <ul style="list-style-type: none"> • DDA to clean the water body from waste and repair the boundary wall. • Boundary wall can be shifted towards road to increase area of water body • Need cleaning outside area of water body

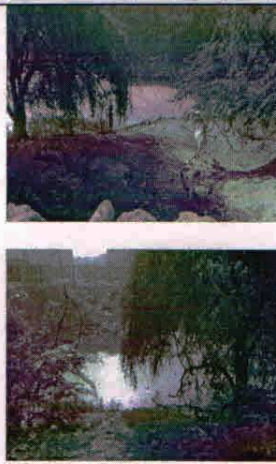
22.	<p>Palam:- Date of Inspection - 29.11.16</p> <p>G. No. 794 Kh. No. 122 (21-12) - DDA</p> <p>On Serial No. 15</p> <p>It is wet with waste dirty water and is also having dumping yard at site. It is under encroachment from 3 sides. New building is also under construction illegally. A court case is reported.</p> <p>Direction:-</p> <ul style="list-style-type: none"> • TSM survey • Removal of encroachment • Cleaning of water • Stopping ongoing building construction • Closing gate for stopping Mule entry • Removal of dumped garbage from entire water body • Planting on its sides. • Bring court case pending before Hon'ble NGT and Court Commissioner. • Plantation on its sides

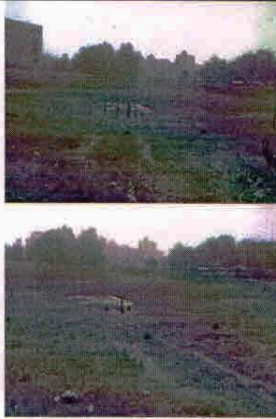
23.	<p>Palam:- Date of Inspection - 29.11.16</p> <p>G. No. 793 Kh. No. 153 (13-10) - DDA</p> <p>It is well developed water body along drain. However, it is dry at present.</p> <p>Direction:-</p> <ul style="list-style-type: none"> • To install Rain Water Harvesting System nearby building for its revival. • Removal of mud spotted at site. • Unauthorized dumping be removed and no further dumping be done in the water body. • Required more deepening at centre of water body • Plantation to be done around the water body. • TSM survey to be done.

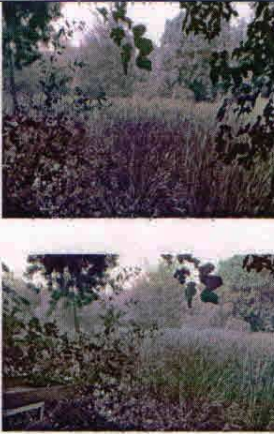
<p>32.</p> <p>G. No. 768</p>	<p>Nasirpur:- Date of Inspection - 30.11.16</p> <p>Kh. No. 612/2 (11-19) - DDA</p> <p>It is partly dry and partly wet with dirty water near to drain. It under encroachments having paper boards industry. It is under Court case.</p> <p>Direction:-</p> <ul style="list-style-type: none"> • Bring Court case before Court Commissioner and Hon'ble NGT • TSM survey • Removing dumping yards and other wastes from water body • Removing encroachments. • Plantation • Cleaning water

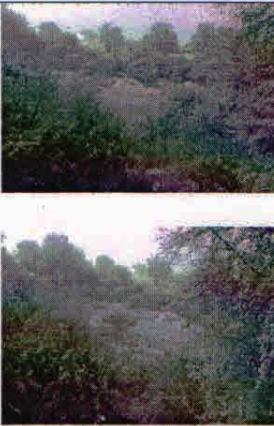
<p>34.</p> <p>G. No. 692</p>	<p>Kakrola:- Date of Inspection - 30.11.16</p> <p>Kh. No. 184 (15-6) - DDA</p> <p>It is seasonally wet. It has Court case for 14 Biswa. It has solid waste dumping at site. It is located along drain and has broken boundary wall.</p> <p>Direction:-</p> <ul style="list-style-type: none"> • TSM survey • Bring Court case before Court Commissioner and Hon'ble NGT • Removal of solid waste dumping and weeds from water body area

<ul style="list-style-type: none"> • RWH from adjoining building • Repair of boundary wall • Plantation around its boundary 	
35. G. No. 693	Kakrola:- Date of Inspection - 30.11.16 Kh. No. 194 (15-4) - DDA It is situated along drain. It is wet at present. Temple is exist on the land of water body. Its boundary wall is broken. Direction:- <ul style="list-style-type: none"> • TSM survey • Cleaning of debris and other waste from site • Repair of boundary wall • Plantation

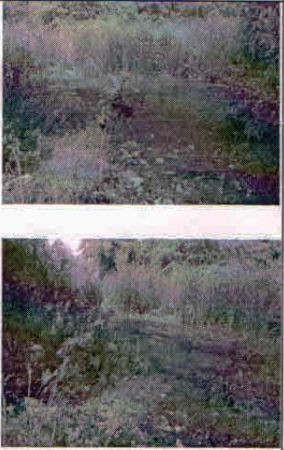
36. G. No. 692	Kakrola:- Date of Inspection - 30.11.16 Kh. No. 192 (8-17) - DDA It is situated along MCD drain. It is wet but has sewage and industrial waste as well as acid is being dumped on the water body land. Encroachment exist as per TSM survey done earlier. Water body has been converted into dumping yard. Direction:- <ul style="list-style-type: none"> • To stop sewage and industrial waste, and other chemical effluents being flowing into the water body • Immediate steps to remove encroachment. • Tree plantation • Boundary wall making without any delay • Weed removal

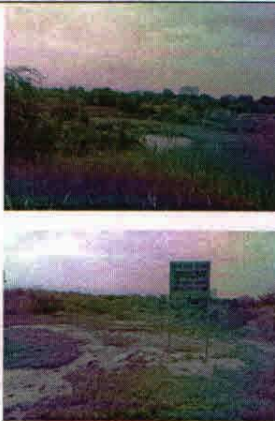
41.	Toganpur:- Date of Inspection - 29.11.16	
G. No. 839	Kh. No. 1/183(12-2) - DDA It is a natural water body and is located in forest area of DDA. It is located at Bharat Vandana Udhaan, Sector-20, Dwarka, measuring 1 Km X 1 Km green area. It can be a very good Biodiversity zone with water body. Proper planning of Biodiversity area with water body with proper path and ecotourism provisions can be a better asset in Dwarka region.

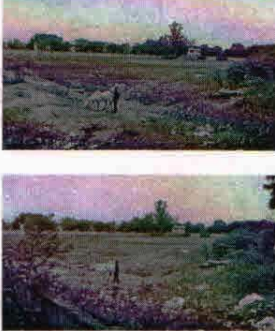
42.	Shahbad Mohd. Pur:- Date of Inspection - 29.11.16	
G. No. 983	Kh. No. 1/72 (28-13) - DDA The water body belongs to DDA exists next to Railway crossing. The people of the village indicated that the said water body used to be filled with water. However it was dry during visit. No catchment of water body was also found. DDA was directed to look into the matter, take remedial measure and submit the report within three weeks.

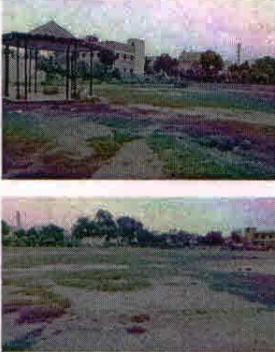
43.	Shahbad Mohd. Pur:- Date of Inspection - 29.11.16	
G. No. 984	Kh. No. 1/535 (31-6) - DDA The water body belongs to DDA. At site park exists. The official of DDA indicated that he has joined recently and will take measures to construct water body. He assured that needful will be done within four weeks and report to that effect be filed before the Court Commissioners. Also tree planting be followed during this rainy season.
