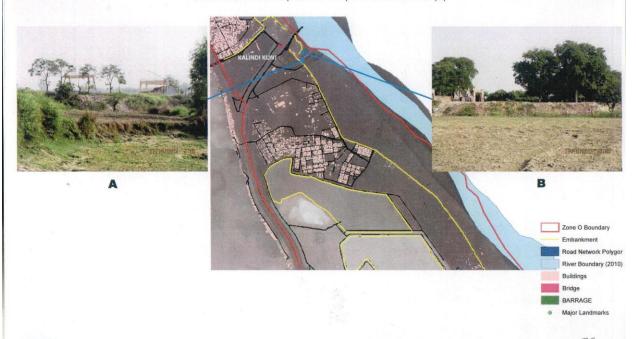
Figure 5: On going construction activity and dumping of solid waste on the active flood plains at Jaitpur
