Sub: Details of Site Inspection of Water Bodies of Dwarka conducted by the Committee constituted under judgment of Hon'ble National Green Tribunal in connection with OA No. 299 of 2016 titled as "Diwan Singh & ANR Vs. Union of India & Ors. held on 15.6.2017 and 16.6.2017.

Site Inspection of Water Bodies of Dwarka conducted by the Committee constituted under judgment of Hon'ble National Green Tribunal in connection with OA No. 299 of 2016 titled as “Diwan Singh & ANR Vs. Union of India & Ors. was done on 15.6.2017. Again on 16.6.2017. Site Inspection of all water bodies related to the case was carried out. Site Inspection detailed report is as follows:-

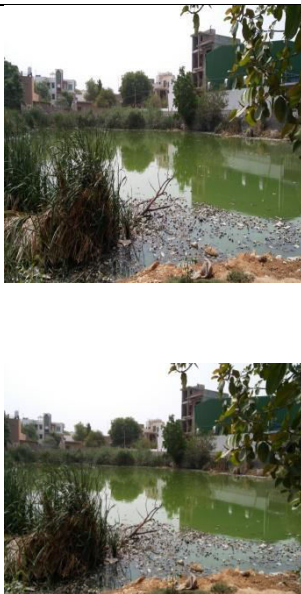
28° 32.718' N 77° 01.992' E Alt. 199 m
---------------------	--	--

1. G. No. 602	Bamnoli:- Date of Inspection - 02.12.16 15.06.17 Kh. No. 232 (earlier 547) (4-15) - DDA It is located in the Village. It is wet due to sewage water flowing into it from adjoining village Bamnoli. Its boundary wall is broken. It has garbage on its side and partly into water body too. Direction:- ➤ DJB should stop sewage entry in to the water body in a week time. DDA should dredge out and clean the water body area. from the waste dumped in the water body without delay. ➤ DJB should also check the quality of water entry into the water body and NEERI can be involved in doing the needful to have clean water entry in to the wetland.

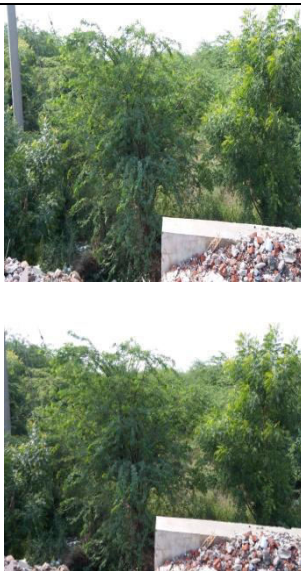
<p>10.</p>	<p>Dhoolsiras:- Date of Inspection - 2.12.16 16.06.17</p> <p>Kh. No. 39/15 (4-16), 39/16(4-16), 39/25/1(2-8), 40/20(2-8) Total area (14-8) - DDA</p> <p>This water body belongs to DDA. It is located behind Shamshan Ghat. It is green area with mostly Kikar plants exist in the Water Body. Its total green area is as depression. Also direction given to maintain it as green area as such.</p> <p>Direction:-</p> <ul style="list-style-type: none"> ➤ DDA to make boundary wall around the water body area. ➤ Maintain it as green area ➤ Small area (600 sqm) is under encroachment stayed by Hon'ble Court. A copy of Court case be given to Court Commissioner Sh. V.K. Tandon and get the stay vacated.

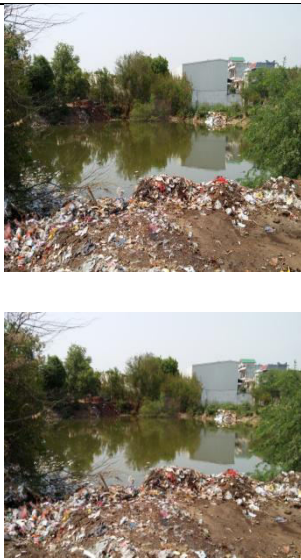
<p>28° 33.257' N 77° 01.929' E Alt. 192 m</p>

<p>28° 33' 391' N 77°02.061' E Alt. 200 m</p>
<p>11.</p> <p>G. No. 636</p>	<p>Dhoolsiras:- Date of Inspection - 29.11.16 16.06.17</p> <p>Kh. No. 72/2 (8-9) - DDA</p> <p>The water body has been converted into a dumping yard. It is partly encroached from sides. It has waste water from adjoining houses. Directions have been given to DDA to make boundary wall around the water body. Immediate measure needs to be taken to stop dumping immediately which is continuously going on in the water body.</p> <p>Direction:-</p> <ul style="list-style-type: none"> ➤ During discussion at site with DDA and with BDO on phone it appears that proper handing over/taking over is the issue. Being urbanized Village, DDA has taken over the land as such. Some repair works have also being done in water body area. Hence directions were given to Revenue Deptt. to do the TSM survey of the site in 15 days time in front of BDO and DDA. DDA was directed to take over the water body as it is and do the needful including cleaning, boundary wall repair, removal of encroachment, planning and maintaining the water body without any delay.

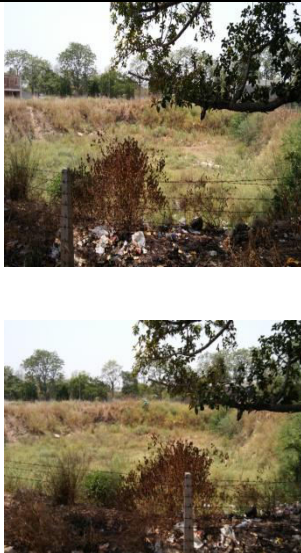
<p>28° 34.215' N 77° 04.602' E Alt. 207 m</p>

16.	<p>Bagdola:- Date of Inspection – 29.11.16 15.06.17</p> <p>Kh. No. 40 (13-9) – DDA</p> <p>This water body is situated at C-Block, Sector-8, Bagdola Village. It is seasonally wet. It is along drain hence rain water can be diverted toward it in a week time.</p> <p>A case of encroachment (By Sh. Bhajan Lal) is to be brought before Court Commissioner in a week time.</p> <p>Direction:-</p> <ul style="list-style-type: none"> ➤ TSM survey is required hence DDA to write to DM (New Delhi)/SDM (Delhi Cantt.) to get the demarcation done from Revenue Deptt. in a week time. ➤ Gate be erected in a week time. ➤ Dumped waste and the Bushes need to be removed in 15 days time. ➤ Boundary wall needs repair in 15 days. ➤ Plantation be done on its side in July' 2017.

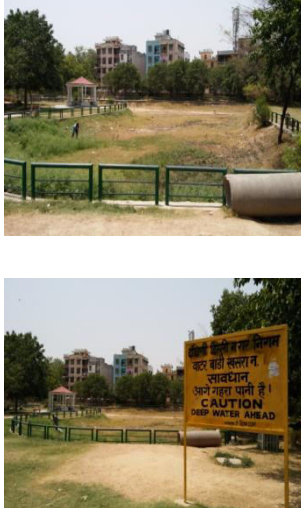
<p>28° 34.366' N 77° 04.255' E Alt. 195 m</p>

17. G. No. 927	<p>Bagdola:- Date of Inspection – 29.11.16 15.06.17</p> <p>Kh. No. 31 (12-00) - MCD (South)</p> <p>This water body belongs to SDMC. It is dry. It is to be connected with adjoining drain in a week time.</p> <p>Direction:-</p> <ul style="list-style-type: none"> ➤ Tree guards to be removed. ➤ Cleaning is in progress. ➤ Plantation to be done this Monsoon.

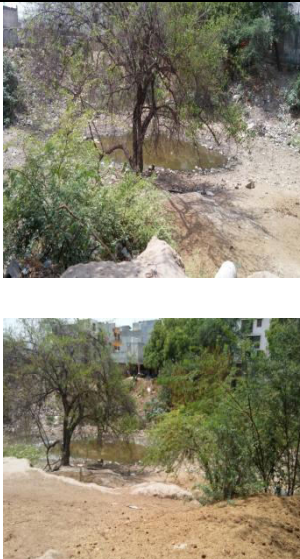
<p>28° 35.386' N 77° 04.413' E Alt. 206 m</p>

<p>22.</p> <p>G. No. 794</p>	<p>Palam:- Date of Inspection – 29.11.16 15.06.17</p> <p>Kh. No. 122 (21-12) - DDA</p> <p>It is wet with waste dirty water and is also having dumping yard at site. It is under encroachment from 3 sides. New building is also under construction illegally. It seems there is no progress since last visit held on 29.11.2016.</p> <p>Direction:-</p> <ul style="list-style-type: none"> ➤ DDA to get the water body fenced of 2 meter. ➤ Close all entries towards water body in one month time. ➤ One gate to be installed on 30 meter road side. ➤ Plantation of tall trees in Monsoon by Hort. Deptt. of DDA. ➤ Removal of encroachment immediately as now no case. ➤ Cleaning of waste water be done in a month time. ➤ Closing gate for stopping Mule entry. ➤ Removal of dumped garbage from entire water body. ➤ SDM and Tehsildar to take report from BDO about area allotment to 20 point programme prior to 2000 in a week as water body area under DDA is about 4 bighas since 2000.

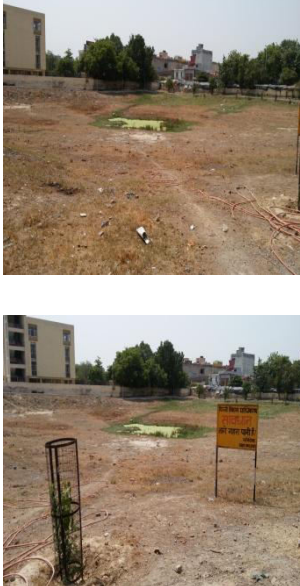
<p>28° 35.457' N 77° 04.429' E Alt. 209 m</p>

<p>23.</p> <p>G. No. 793</p>	<p>Palam:- Date of Inspection – 29.11.16 15.6.17</p> <p>Kh. No. 153 (13-10) – MCD (South)</p> <p>It is well developed water body along drain. However, it is dry at present.</p> <p>Direction:-</p> <ul style="list-style-type: none"> ➤ To install Rain Water Harvesting System nearby building and area for its revival. ➤ Connect to adjoining drain in a week time. ➤ Unauthorized dumping be removed in a week time and no further dumping be done in the water body. ➤ Plantation and cleaning to be done around the water body during Monsoon.

<p>➤ MCD to demand area for Dhalao from DDA in a week time and DDA to give land to MCD without delay.</p>	
24.	<p>Pochanpur:- Date of Inspection – 02.12.16 16.06.17</p> <p>Kh. No. 6/18 - DDA</p> <p>It is located in Sector-19(B), Dwarka where old trees of Peepal and Neem are existing. According to DDA, there is no water body exist here. Presently fresh earth has been filled up. Revenue Deptt. present during visit also reported this area being agriculture earlier.</p> <p>Direction:-</p> <p>➤ Sufficient tree plantation in the planned area.</p>

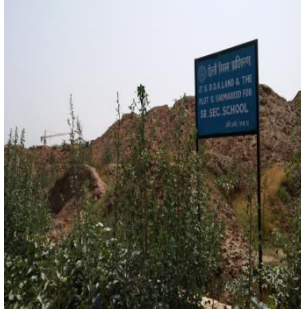
<p>28° 34' 237" N 77°02.621" E Alt. 200 m</p>

25.	<p>Date of Inspection – 30.11.16 16.06.17</p> <p>Amberhai (Earlier reported as Pochanpur):- Chhattar Ka Johar</p> <p>Kh. No. 45/16 & 45/17 - DDA</p> <p>Sh. Diwan Singh stated in his list that this land is called as “Chattar ka Johar” but according to DDA as well as Revenue Deptt. there is no water body exist here. Presently fresh earth has been filled up. It has been acquired in 1992 by DDA as agricultural land as told during inspection on 30.11.2016. DDA and Revenue officials reported that agricultural area belongs to Sh. Chhattar Singh, had his own well here but Joha/pond was never existed in records here also reported by Revenue authorities. However, park/green area can be planned at site along with other planning.</p> <p>Direction:-</p> <p>➤ Sufficient tree plantation in the planned area.</p>

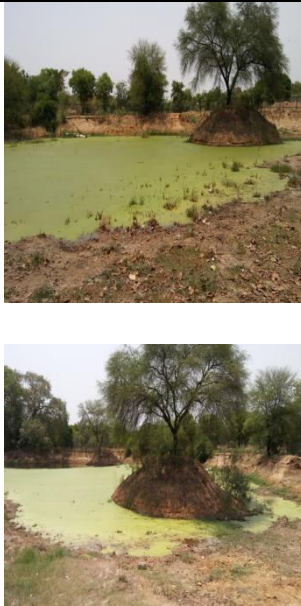
<p>26.</p>	<p>Pochanpur:- Date of Inspection – 29.11.16 15.06.17</p> <p>Kh. No. 33 (5-10) - DDA</p> <p>It is wet at present. It is a natural water body with an area of 5 bigha and 10 biswa and is located in green area of DDA at District Park measuring about 35 acres, Sector – 23, Dwarka. It is wet. It is located near drain hence can be joined with it for having water.</p> <p>Direction:-</p> <ul style="list-style-type: none"> ➤ Plantation around the water body as suggested during visit. ➤ Repair and clean the channels in 15 days time. ➤ DJB is directed to do water augmentation activities at site from adjoining drain and other sources. ➤ If possible, shift play area from water body side to adjoining plot of the park and make the existing play area as green for proper ground water recharge and catchment to water body.

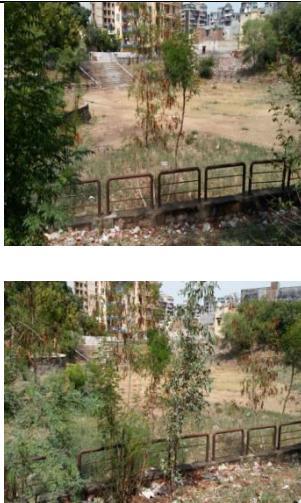
<p>28° 34.726' N 77° 02.933' E Alt. 199 m</p>

<p>28° 34.062' N 77° 03.151' E Alt. 198 m</p>
<p>27.</p> <p>G. No. 584</p>	<p>Amberhai:- Date of Inspection – 29.11.16 16.06.17</p> <p>Kh. No. 57 (7-0) – DDA</p> <p>It is located along Drain and is seasonally wet. Waste Dump was found in the Water Body. Cleaning is to be done by DDA in a week time.</p> <p>Direction:-</p> <ul style="list-style-type: none"> ➤ Boundary wall to be repair along with gate in 15 days time. ➤ Plantation around the water body this Monsoon. ➤ Rain water harvesting from adjoining building and road through pipe/channeling etc.

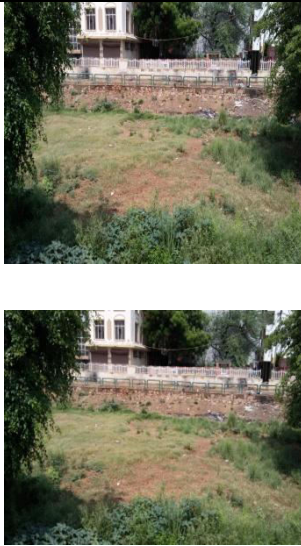
<p>28.</p> <p>G. No. 585</p>	<p>Amberhai:- Date of Inspection – 29.11.16 16.06.17</p> <p>Kh. No. 33/9 & 33/10 – DDA</p> <p>It is along drain. The water body is on the road side.</p> <p>Direction:-</p> <ul style="list-style-type: none"> ➤ DDA to give the total area of the water body at present inside the wall. ➤ Cleaning is in progress and be completed in a week time. ➤ To plant more trees around the boundary wall of water body this Monsoon.

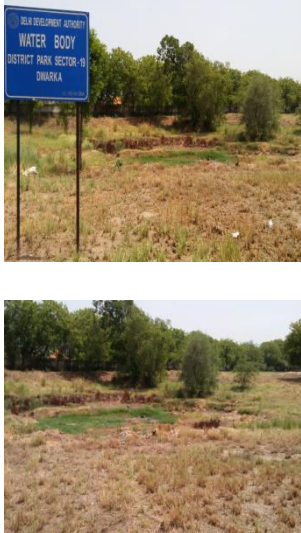
<p>28° 34.950' N 77° 02.860' E Alt. 204 m</p>

<p>28° 34.604' N 77° 02.735' E Alt. 197 m</p>
<p>29.</p>	<p>Amberhai:- Date of Inspection – 02.12.16 16.06.17</p> <p>Kh. No. 14/11 min (4-16) - DDA</p> <p>This water body belongs to DDA. It is low lying area and seasonally wet. It is located in District Park, Sector-19, Dwarka. It is under high tension line near Sports Complex site.</p> <p>Direction:-</p> <ul style="list-style-type: none"> ➤ Water augmentation from adjoining area of park through channelizing/piping etc. ➤ Further plantation is required to be done in entire area of park around water body this Monsoon. ➤ Revenue Deptt. to record it as water body in 15 days time.

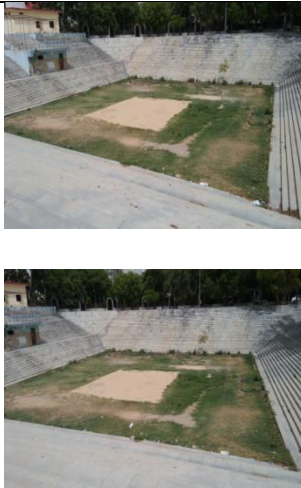
<p>28° 55.957' N 77° 04.418' E</p>

<p>28° 34.484' N 77° 03.094' E Alt. 207 m</p>
45.	<p>Pochanpur:- Date of Inspection – 16.6.17</p> <p>Kh. No. 35 (4-16) – DDA</p> <p>This water body is located in inside the temple. It is dry at present.</p> <p>Direction:-</p> <ul style="list-style-type: none"> ➤ Clean water be diverted from adjoining road to the water body. ➤ Plantation be done this Monsoon.
